CLARIFICATION No. 02

COMPLETION OF 132KV SONDU-HOMABAY-AWENDO TRANSMISSION PROJECT - TRANSMISSION LINE

SUBJECT: TRANSMISSION LINE MATERIAL VERIFICATION

SUBJECT: INSPECTION OF ERECTED TOWERS AND FOUNDATIONS

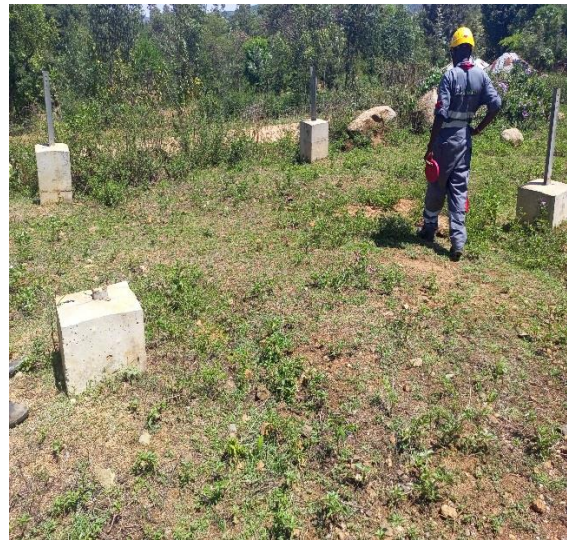
The diagonal profiles were ok. The stubs were all ok apart from Tw 47 and 65 which had one stub each deformed. Tw 47 had stub A deformed and cut. Tw 65 had stub C twisted as a result of nearby construction work involving heavy machinery.

Tower 47, stub A deformed and cut

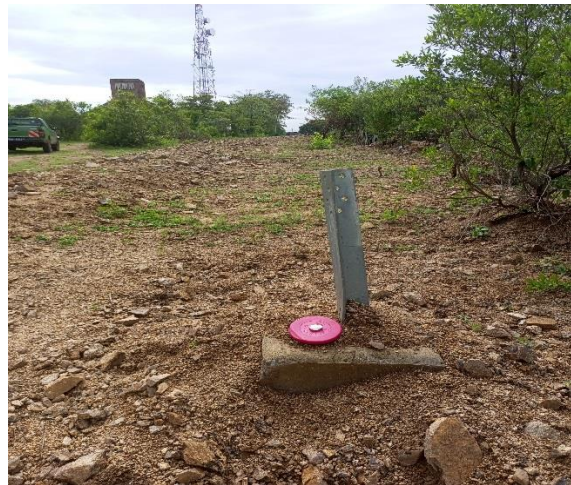
Tower 65, Stub twisted and deformed

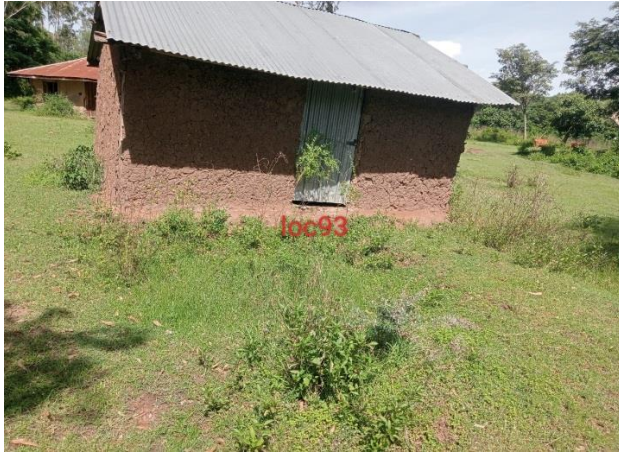
All foundations had been constructed apart from Tw 1, 2, 3, 56, 92 and 93. Towers 1, 2, 3 are under the LILO design for Thurdibuoro substation. Tw 93 has a house constructed on the foundation point. Tw 56 had been excavated but the pits have filled up with soil.

Tw 93, house built at exact tower position

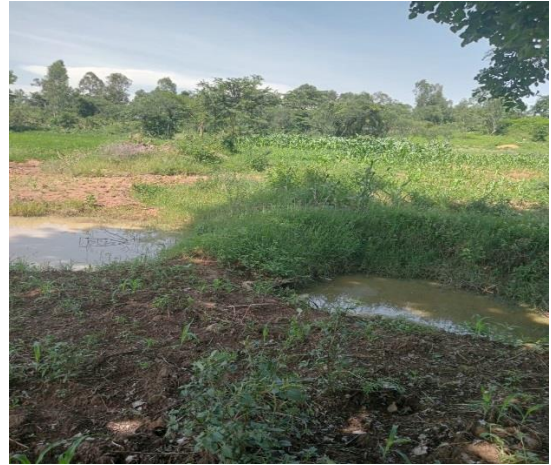
T 92, excavated but not constructed

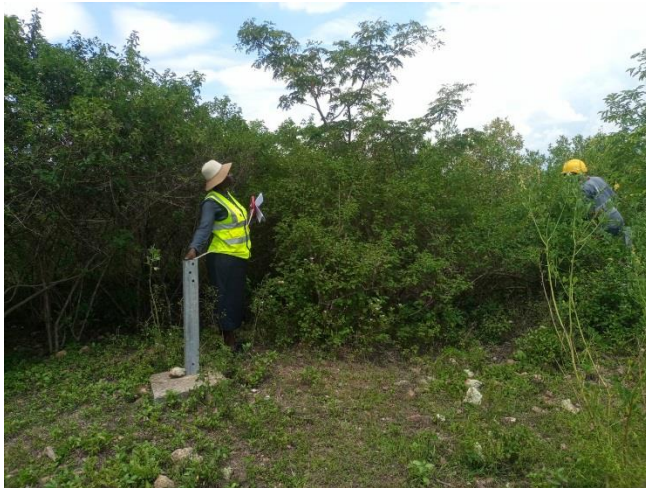
1. Accessibility was a problem in some areas. Tw 108 was constructed within a rice plantation which was surrounded by irrigation water.
2. Heavy vegetation and trees had grown on tower foundations like for tw 53, 146 which required heavy bush clearing in order to measure the stub diagonals.
3. Huge gulleys had formed in some locations and this made access to such locations very difficult and walking was now an option. Tw 29, 41, 27 were near developing gulleys.
4. Hilly and rocky terrain where some foundations had been constructed. Access to locations 145, 144, 143, 142, 141, 140 and 139 was a real challenge.

Tw 146, heavy vegetation at foundation

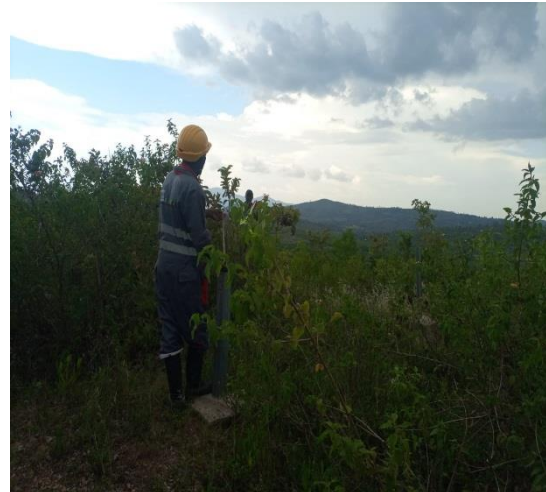
Tw 144, taking stub diagonals, hilly terrain

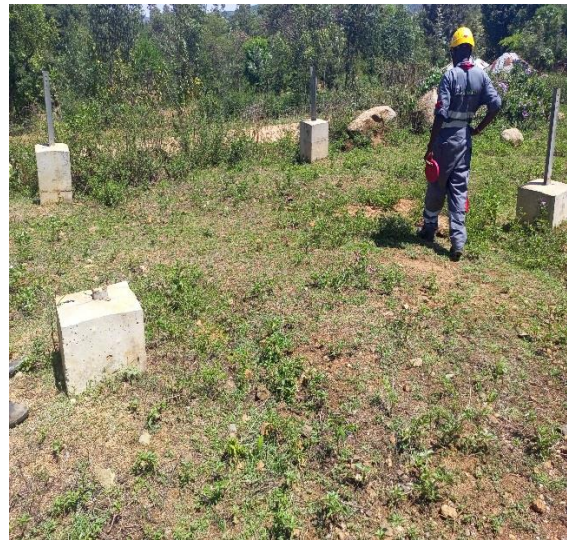
The diagonal profiles were ok. The stubs were all ok apart from Tw 47 and 65 which had one stub each deformed. Tw 47 had stub A deformed and cut. Tw 65 had stub C twisted as a result of nearby construction work involving heavy machinery.

Tower 47, stub A deformed and cut

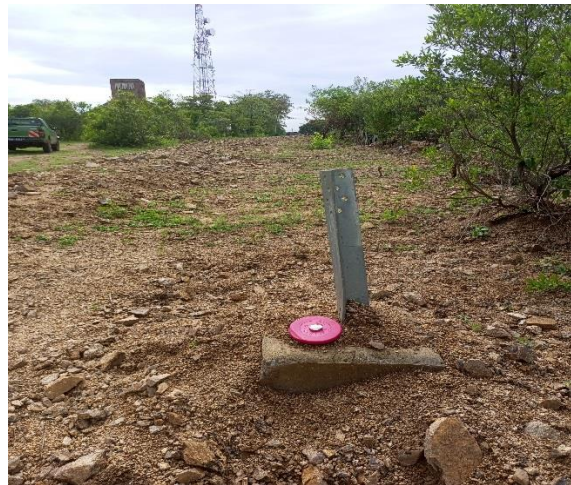
Tower 65, Stub twisted and deformed

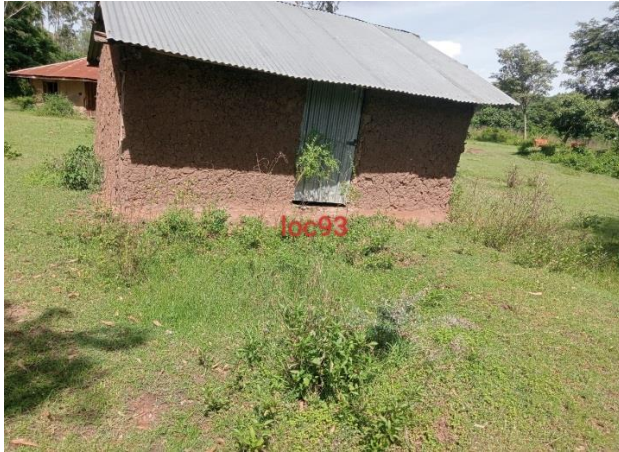
All foundations had been constructed apart from Tw 1, 2, 3, 56, 92 and 93. Towers 1, 2, 3 are under the LILO design for Thurdibuoro substation. Tw 93 has a house constructed on the foundation point. Tw 56 had been excavated but the pits have filled up with soil.

Tw 93, house built at exact tower position

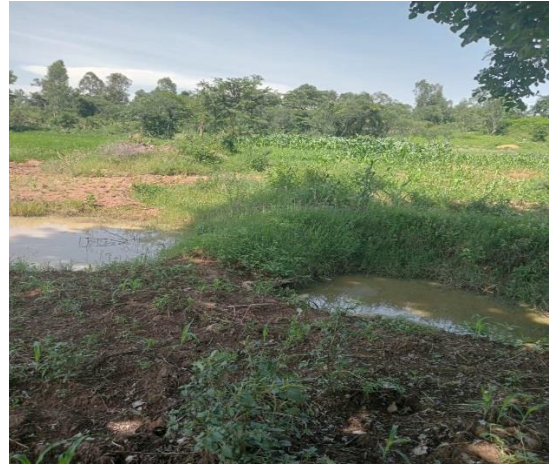
T 92, excavated but not constructed

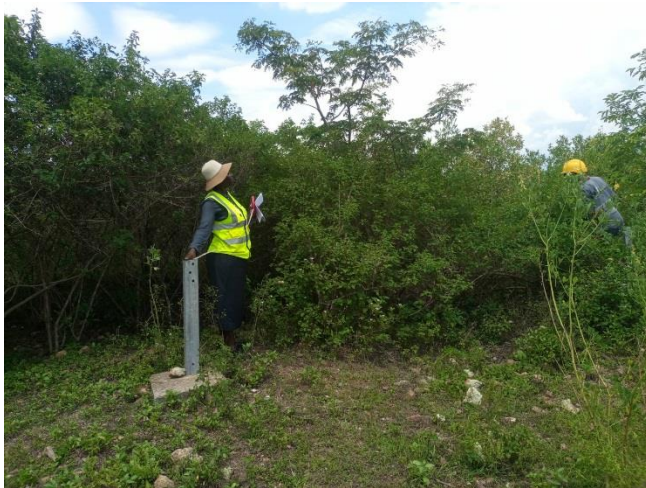
1. Accessibility was a problem in some areas. Tw 108 was constructed within a rice plantation which was surrounded by irrigation water.
2. Heavy vegetation and trees had grown on tower foundations like for tw 53, 146 which required heavy bush clearing in order to measure the stub diagonals.
3. Huge gulleys had formed in some locations and this made access to such locations very difficult and walking was now an option. Tw 29, 41, 27 were near developing gulleys.
4. Hilly and rocky terrain where some foundations had been constructed. Access to locations 145, 144, 143, 142, 141, 140 and 139 was a real challenge.

Tw 146, heavy vegetation at foundation

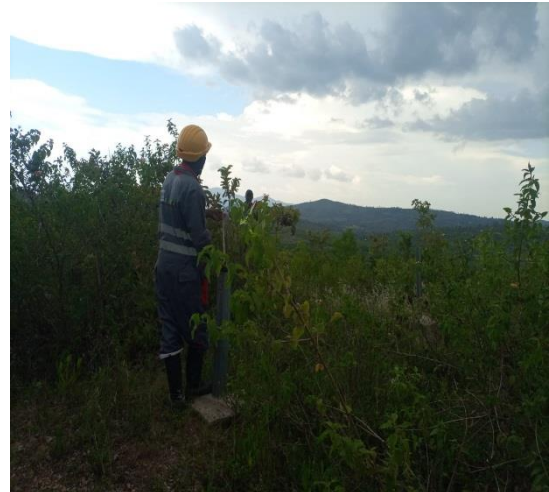
Tw 144, taking stub diagonals, hilly terrain
